Geological Study Majdel Baana Facility

1. Site Visit and Findings

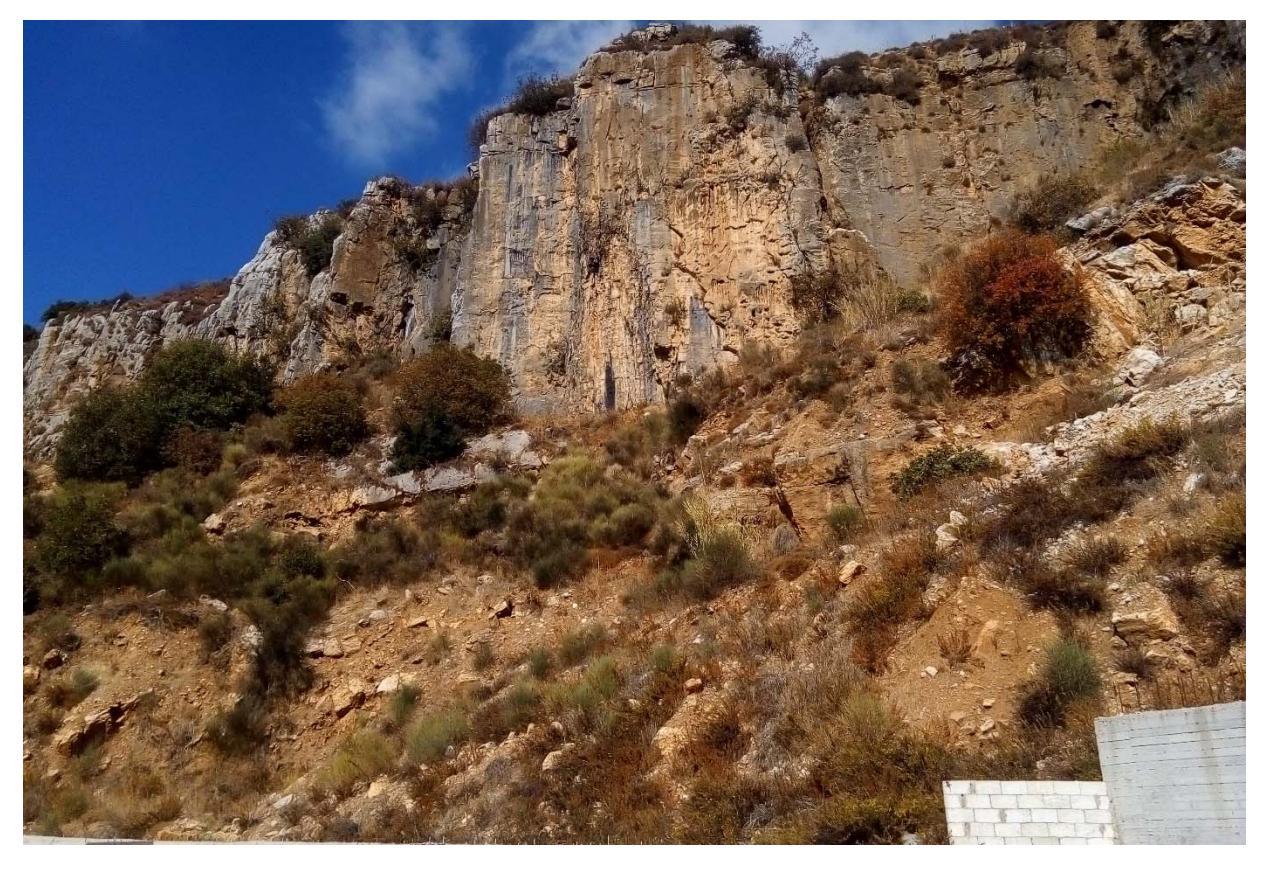
Photo 1– Show the limestone cliff (C2a2) and loose materials required to be removed overlay the Aabay formation(C2a1).

- Remove all loose material or accumulated material above the proposed facility resulting from weathering of the mother rocks.
- Remove the rocks close to the western concrete wall.

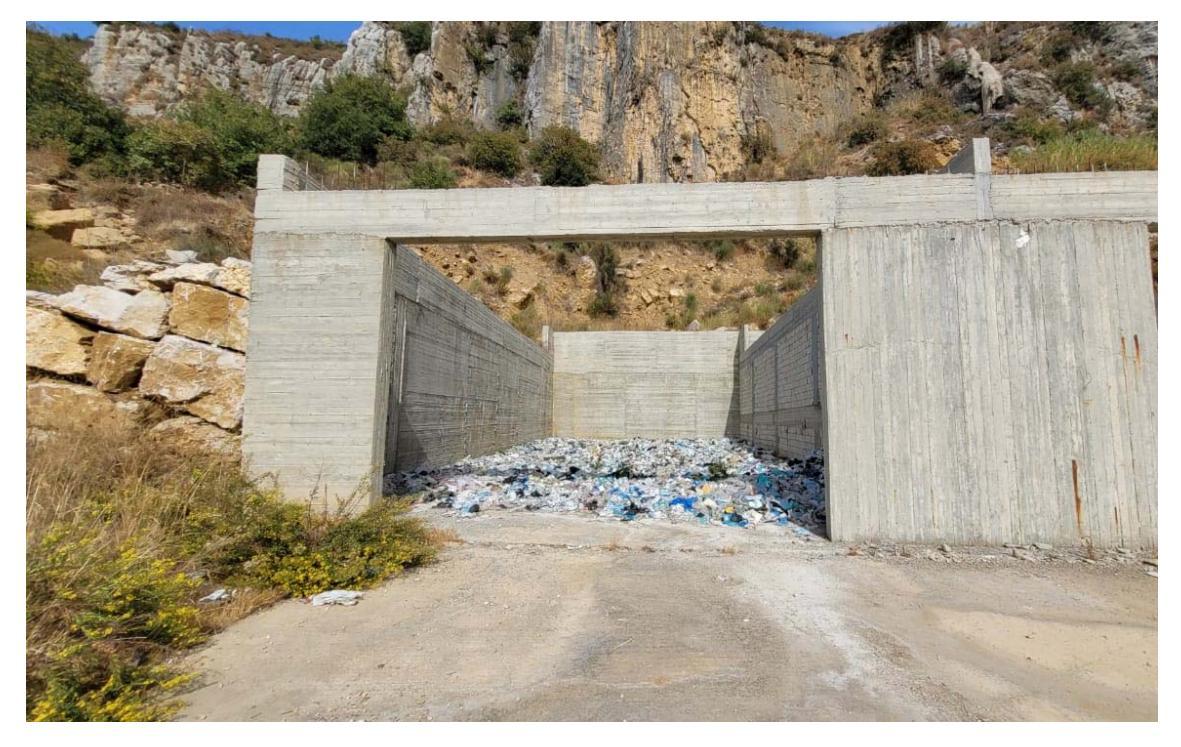
Photo 2– Show on the left side the rocks limestone required to be removed.

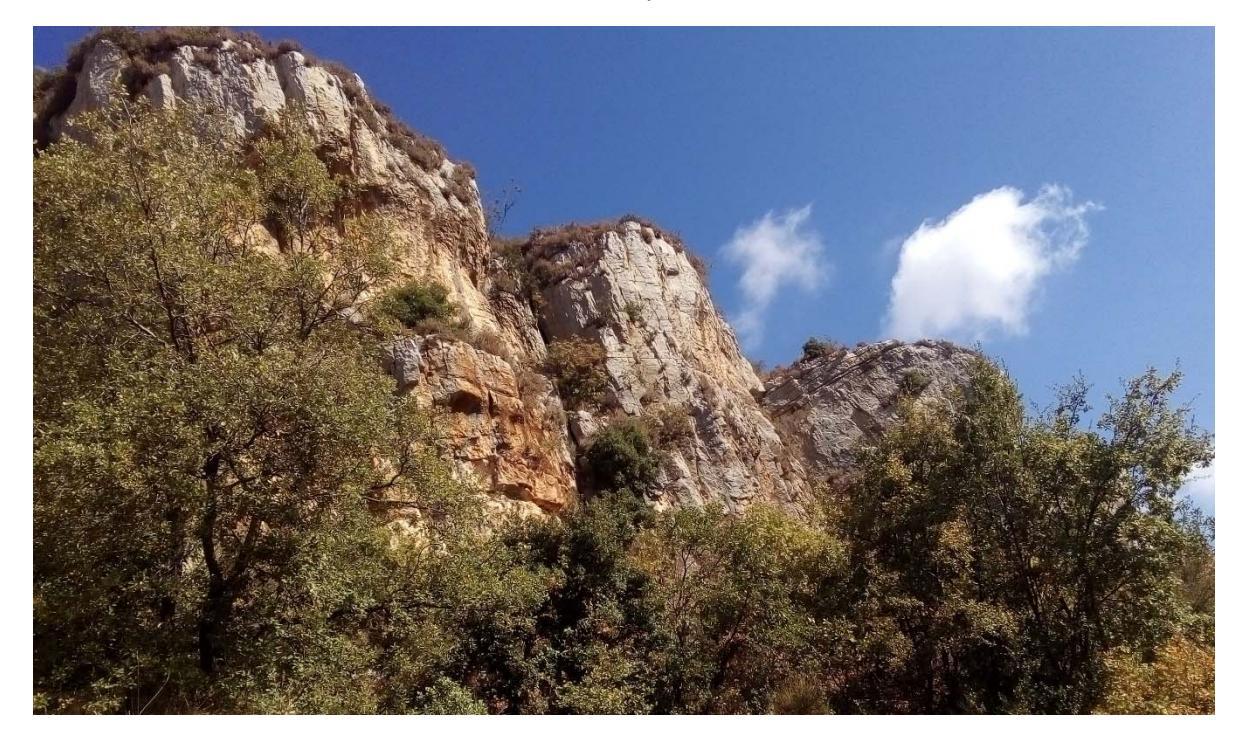
Photo 3 – Show the limestone layers dipping toward the north west.
